Manhole Inspection Summary

Manhole # S09A1_007MH

Insp Date: **5/14/08 11:59 AM**

Location Address: **3601 Benson AV**

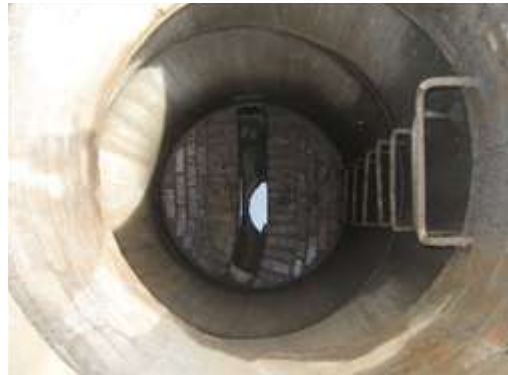
Top View

signs of infiltration noted at seams of manhole

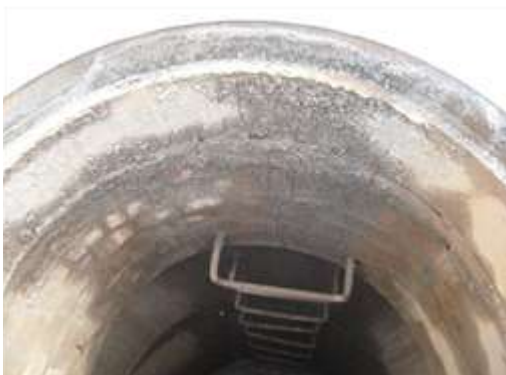
Defect 1

Frame Offset: **0** (in.) Condition: ☐ Sound ☐ Cracked ☒ **Leaks**

signs of infiltration from lid frame connect

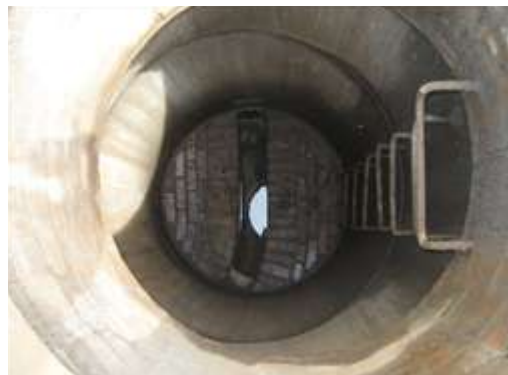
Defect 2

Infiltration: ☐ None ☒ **Joint** ☐ Cracks ☐ Mortar ☐ Roots ☐ Wall

Corbel and barrel infiltration at joint

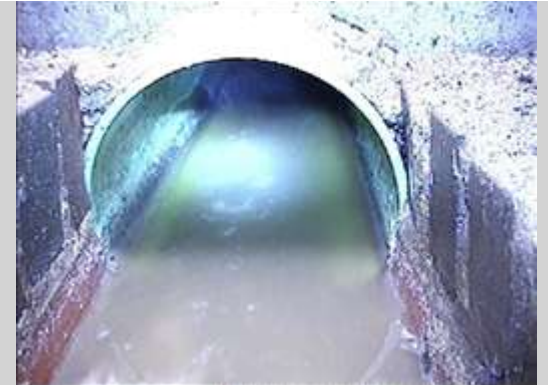
12 O'Clock Outflow

Pipe Height: **8.4** (in.) Rod and Bar (Angled)
Pipe Material: **PVC** ☐ Pipe Lined
Invert Depth: **11.00** (ft.) Flow Characteristics: **Slow**
Deposits: ☒ None ☐ Mud ☐ Sludge ☐ Debris ☐ Grease
Silt Depth: **0** (in.) Deposits Extent:
Infiltration: **None** Pipe Seal Cond: **Sound**

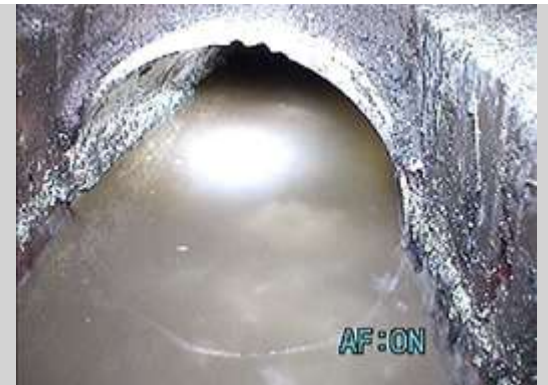
7 O'Clock Inflow

Pipe Height: **8.4** (in.) Rod and Bar (Angled)
Pipe Material: **PVC** ☐ Pipe Lined
Invert Depth: **11.10** (ft.) Flow Characteristics: **Slow**
Deposits: ☒ None ☐ Mud ☐ Sludge ☐ Debris ☐ Grease
Silt Depth: **0** (in.) Deposits Extent:
Infiltration: **None** Pipe Seal Cond: **Sound**
